# Memorandum

Subject : Submittal of Start-up Report for San Francisco Bay Regional Water Quality Control Board Permit (RWQCB Order No. R02-2004-0063, amended May 9, 2007) and San Francisco Bay Conservation and Development Commission Permit (Permit # 8-04, Amendment #1 dated January 18, 2008) Requirements; California Department of Fish and Game, Napa-Sonoma Marshes Wildlife Area, Napa Plant Site Restoration Project, Napa County

## Salinity Reduction Breach Monitoring Data (Tables and Summary Charts)

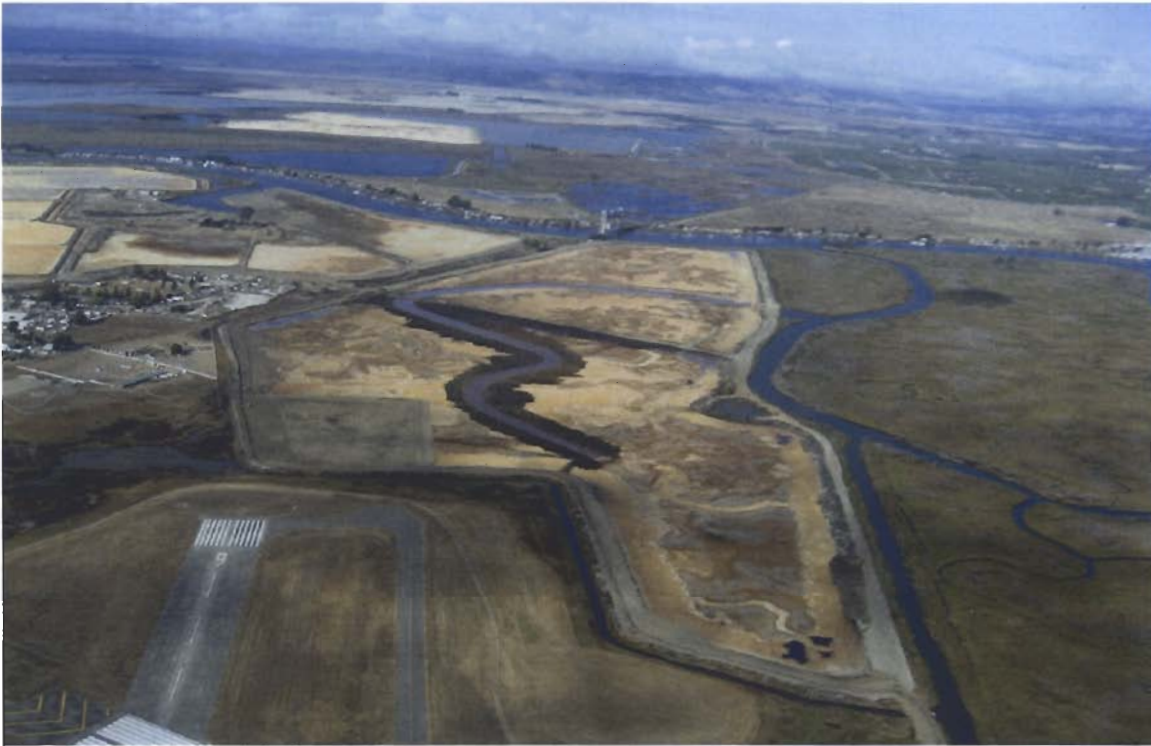
Figure 2. This aerial view clearly displays the reconstructed historic channel before the NUB was breached. Photo Courtesy The Dutra Group, September 2008.

The NUB, located on the levee dividing Pond 9 and the Fagan Slough, was opened to tidal action on October 13, 2008 (Figures 2-6). Tables 1 through 5 summarize the temperature, salinity, pH, turbidity, and DO, respectively. Please refer to Figures 1 for sample locations.

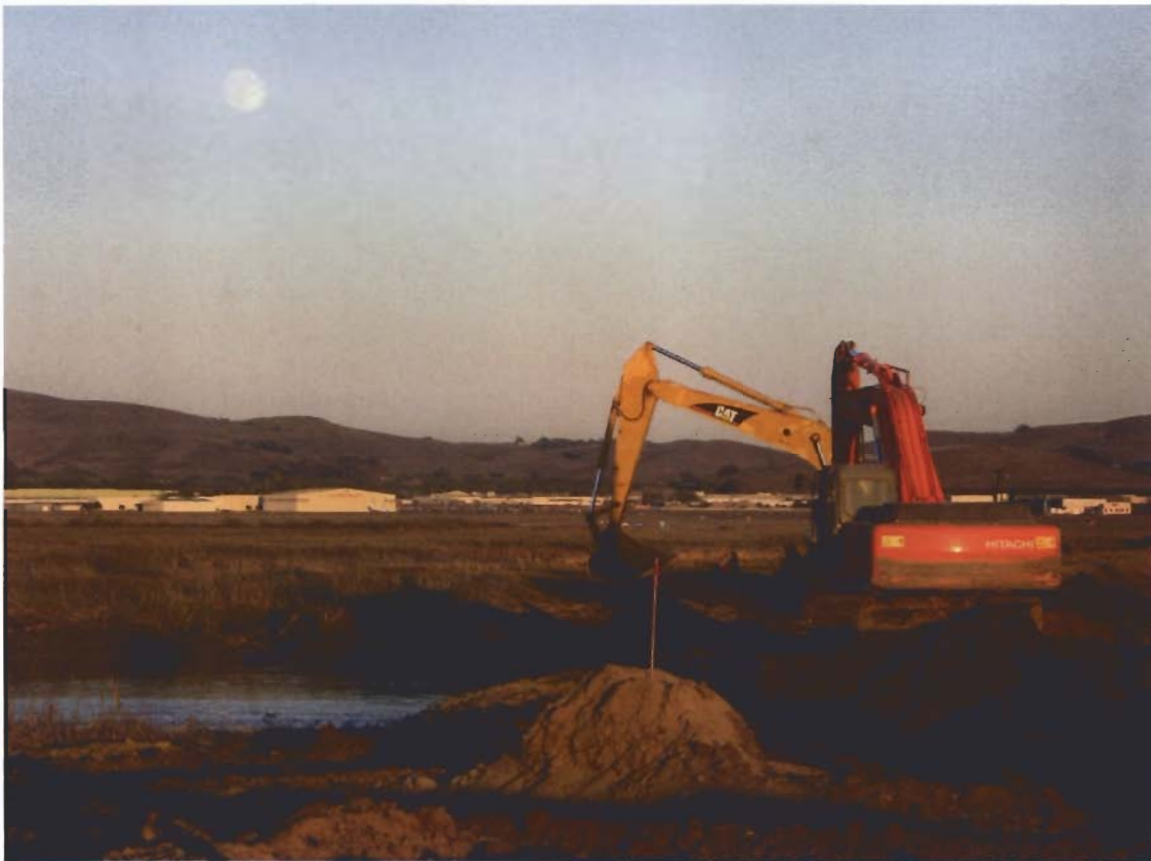
Figure 3. Completing construction of the NUB as Ponds 9 and 10 were opened to tidal action. Photo Courtesy of Ducks Unlimited, October 13, 2008.

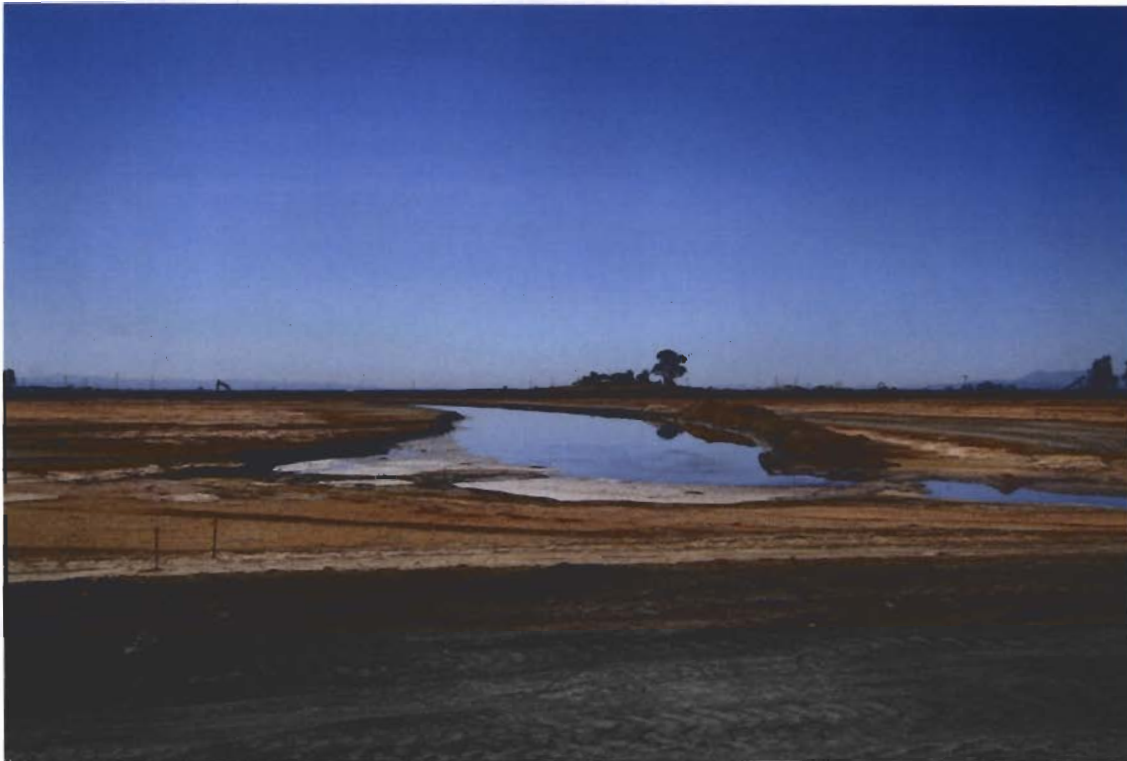
Figure 4. This photo was taken from the future NUB location. It was not feasible to pump out the water in the channel before breaching on October 13, 2008. K. Taylor, September 3, 2008

- A small "plug" of unexcavated pond bottom was left in the new channel due to the ground water therein (Figures 4 and 5). As part of the restoration project, the main historical slough channel was excavated to allow better tidal exchange in the far reaches of Ponds 9 and 10. The improved tidal exchange is designed to accelerate habitat formation and avoid water quality effects (such as low DO) that could result from inadequate exchange. The reconstructed channel is located below the water table (below the pond bottom). Since the ponds were formerly hay fields, and much of the material in the bottom of the pond consists of peat, the soil is extremely porous and water immediately filled the channel excavation as the channel was being constructed. The construction contractor attempted to dewater the channel; however, the channel refilled so quickly that all attempts failed. The contractor also dug several small test pits and attempted to dewater the test pits; however, the same phenomenon was encountered, indicating that even longer-term dewatering efforts would not be effective. As a best management practice, a "plug" was created just inside the pond at the NUB breach location to minimize any potential impacts from a large plume of salt water entering the watershed in one tidal cycle. This "plug" eroded within a week, just long enough for the channel water to discharge gradually into the system. This plan assured that any potential impacts would not adversely affect the nearby habitat.

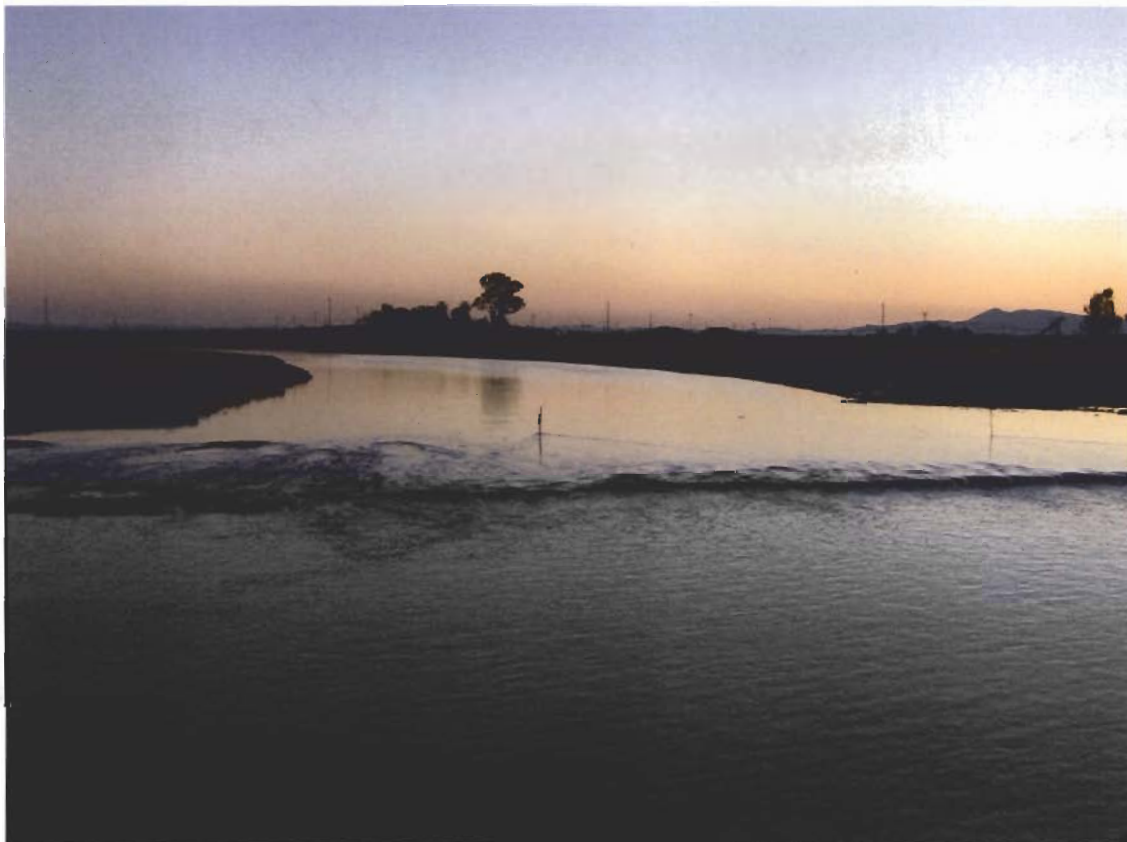
Figure 5. This photo was taken from the NUB location. The break in the channel is the constructed "berm" minimizing potential impacts and spreading the large plume of salt water entering the watershed over several tidal cycles. Photo Courtesy of Ducks Unlimited, October 13, 2008.

While the water quality endpoint cannot be achieved until three months following the NUB, criterion (except for turbidity) was met within 24 hours of the breach (see Appendices A and C). Turbidity data exceedences were minimal (3-7 NTU above Napa River) with the exception of October 17, 2008 where the temporary "plug" began to erode and deteriorate as planned.

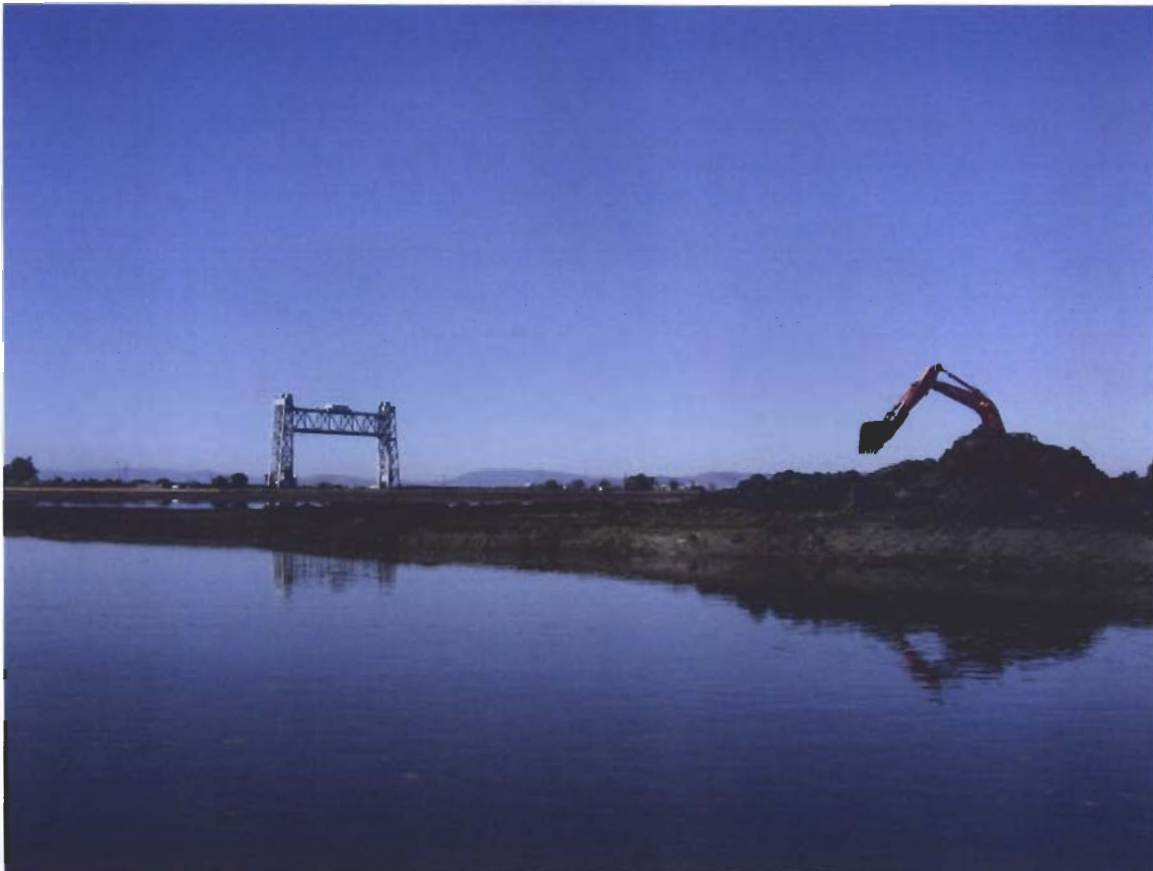
Figure 6. Levee lowering continues once the NUB was completed. One and one half tidal cycles have occurred when this photo was taken. K. Taylor, October 14, 2008

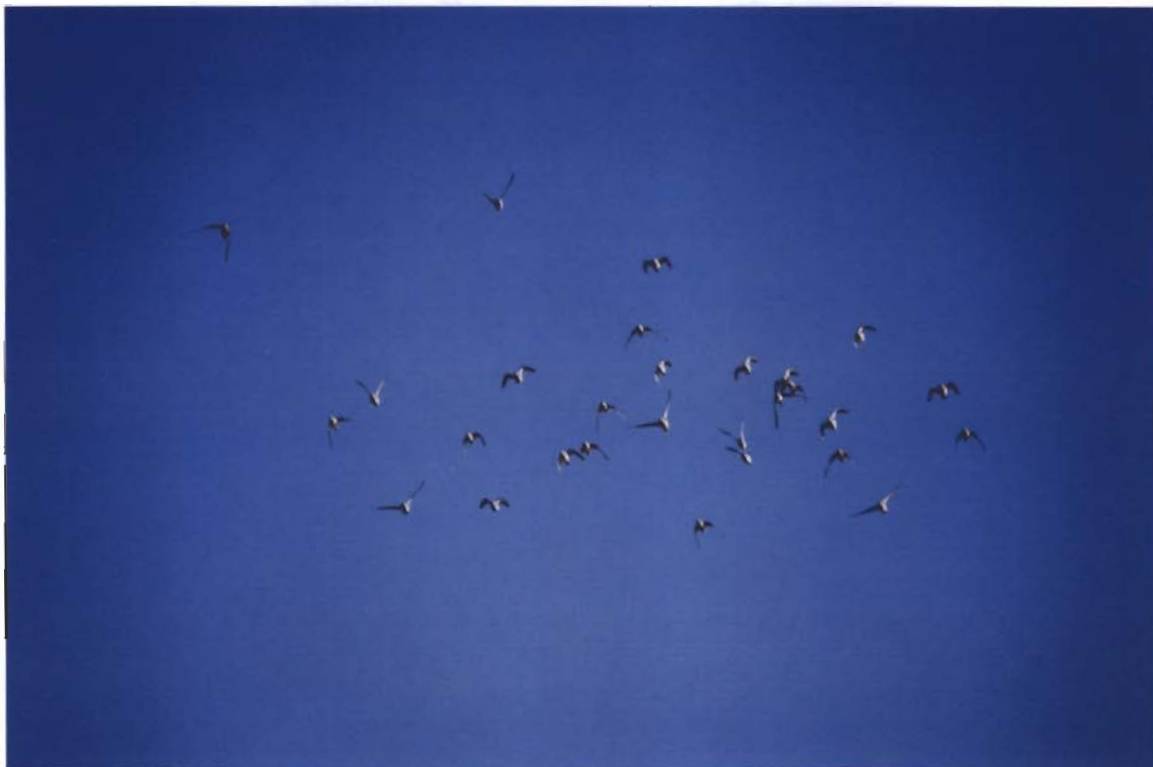
Figure 7. Wildlife immediately responded positively to the new change in their environment. Western sandpipers, snowy egrets, and even a harbor seal visited the restoration project within Ponds 9 and 10 in the first several days of opening the NUB. K. Taylor, November 6, 2008

Wildlife observations were documented and verbally noted by the contractor during construction. It was apparent that wildlife immediately responded in a positive manner to the new change in their environment. Western sandpipers, snowy egrets, and killdeers began utilizing Ponds 9 and
